NACA RM E53G02

PRELIMINARY INVESTIGATION OF SEVERAL ROOT DESIGNS FOR
CERMET TURBINE BLADES IN TURBOJET ENGINE

II - ROOT DESIGN ALTERATIONS

By A. J. Meyer, Jr., G. C. Deutsch, and W. C. Morgan

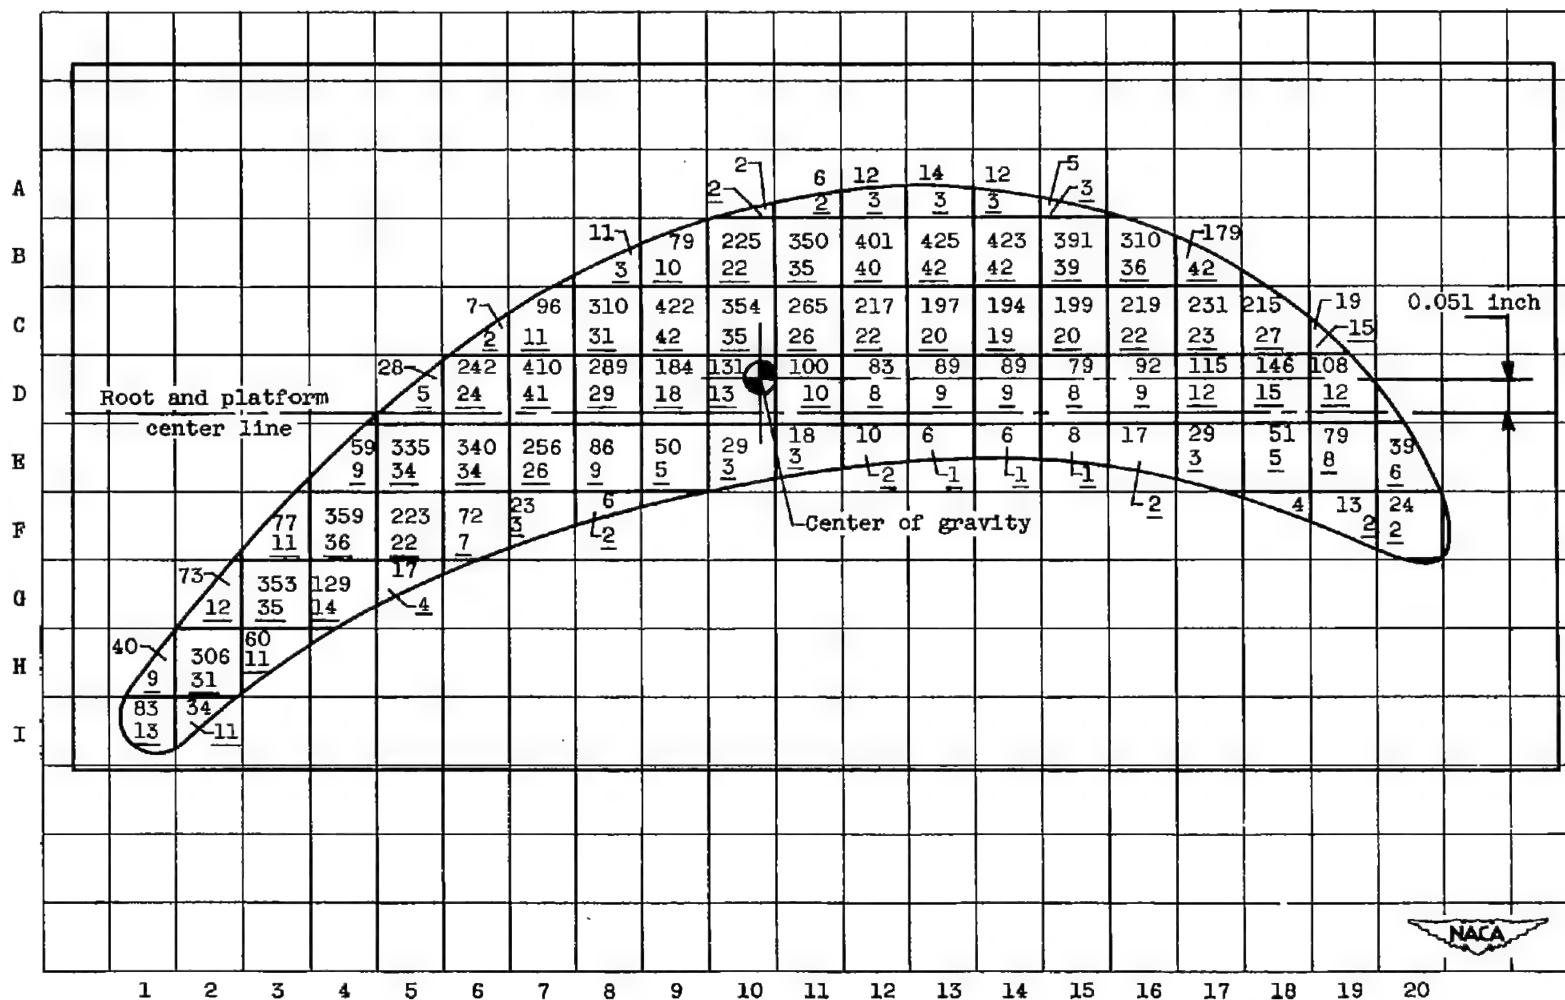
Results of calculation. - The results of the calculations are shown in figure 10. The upper numbers in each square are the total centrifugal forces in pounds acting on each square and the lower numbers (under-scored) are the stresses (in 1000-psi units) that would be acting on the base plane squares if each column were cut free from its neighbors. Actually, there would be a gradual variation in stress from one square to the next. From the magnitude of the numbers presented and their location, it is obvious that the greatest centrifugal loads and stresses are in the region where most of the failures originated. The location of the radial projection of the center of gravity of the whole airfoil is determined by dividing the summation of moments of the centrifugal force of the individual columns times their distance from an arbitrary axis by the summation of the centrifugal forces.

Effect of offset center of gravity. - The procedure described shows the projection of the center of gravity on the base plane to be displaced 0.051 inch in the direction of rotation from the center line of the blade platform and root. This offset introduces a sizable bending moment in the blade root which is only partly compensated for by the gas forces on the airfoil. The gas force per blade as determined in the appendix of this report is 100 pounds at rated speed and

Figure 10. - Centrifugal force and stress distribution at base cross-section of airfoil.

The bending stress resulting from this computation is ± 6990 pounds per square inch. If then the airfoil is shifted 328 divided by 11,300, or 0.029 inch, in the tangential direction toward the concaved or pressure side of the blade, this bending stress can be virtually eliminated.

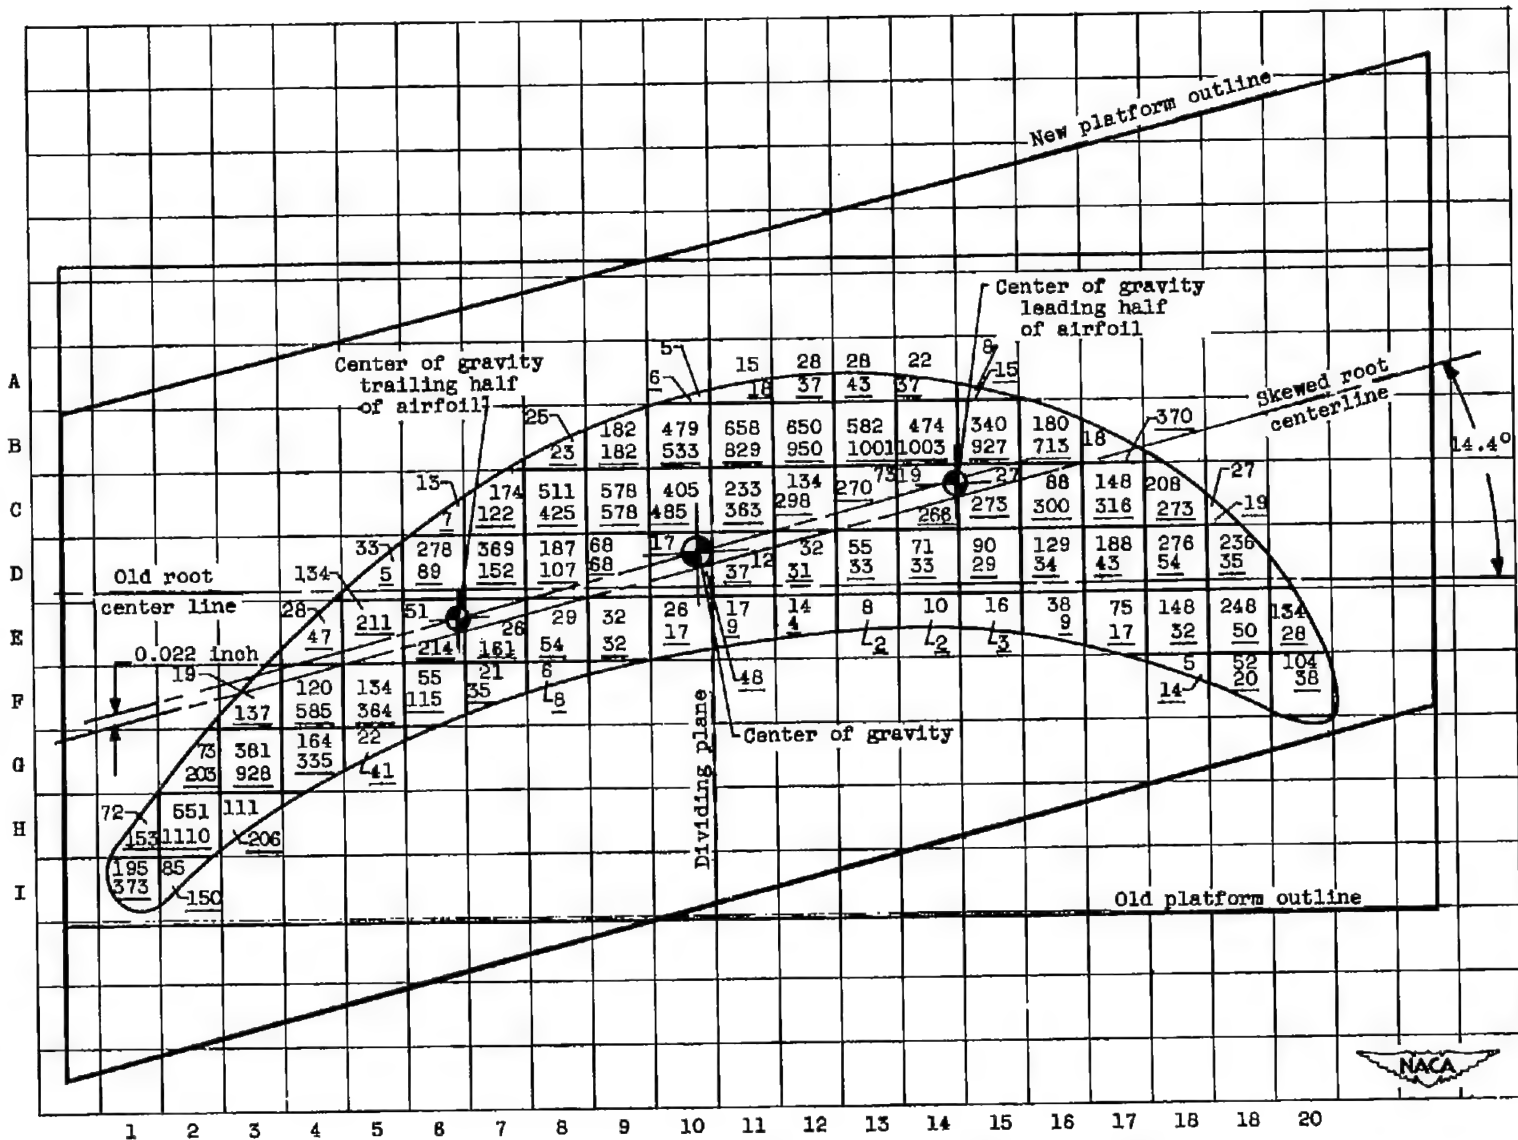
Determination of skewing angle. - The skewing angle was established by finding the centers of gravity of the leading and trailing halves of the airfoil. Assume that the blade is cut lengthwise by a dividing plane through the midchord points and perpendicular to the turbine axis. Then the radial projection of the centers of gravity of each half on the base plane can be readily calculated from the previous computations, and a line drawn through these centers was used to determine the skewing angle, which in this case is 14.4° (see fig. 11).

Effect of skewed root. - The largest number with the old center line is 1110, square 2-H, which might intimate that failure should have started in the root below the trailing edge. However, surrounding values are considerably less and thus would tend to reduce the peak stress at this location. The second largest number with the old center line is 1007, square 13-B, and is flanked by similar high values and therefore would be expected to influence the point where the root failures originated. The actual failure did start in this area.

The largest number with respect to the new center line is 658 (square 11-B), or appreciably less than the largest with the old axis. The 1110 value is reduced to 551, or by about one half. The 1007 value is also about halved, or is 582. The values in the vicinity of the leading edge are multiplied four or five times, but the values are still relatively low because the leading edge of the airfoil is swept back rapidly as the distance from the turbine axis increases. Consequently, skewing the blade root with respect to the airfoil and turbine axis should prove very beneficial.

Figure 11. - Relative bending moment comparison for standard and skewed roots.

The root center line should be offset from the line thus established sufficiently (0.022 inch in this case) to compensate for the bending moment caused by the gas force. In figure 11, the numbers within the airfoil are the products of the centrifugal force of the long thin individual columns used earlier and their distance from the old (parallel to turbine axis) and new (skewed) center lines of the platform and root. The lower numbers (underlined) in each square are for the old center line and the upper numbers correspond to the skewed center line. The exact values of these numbers are not a direct measure of the actual stress distribution in the root, but the relative magnitudes of the numbers are indicative of the amount of overhang or the stress magnitude in corresponding areas in the root.

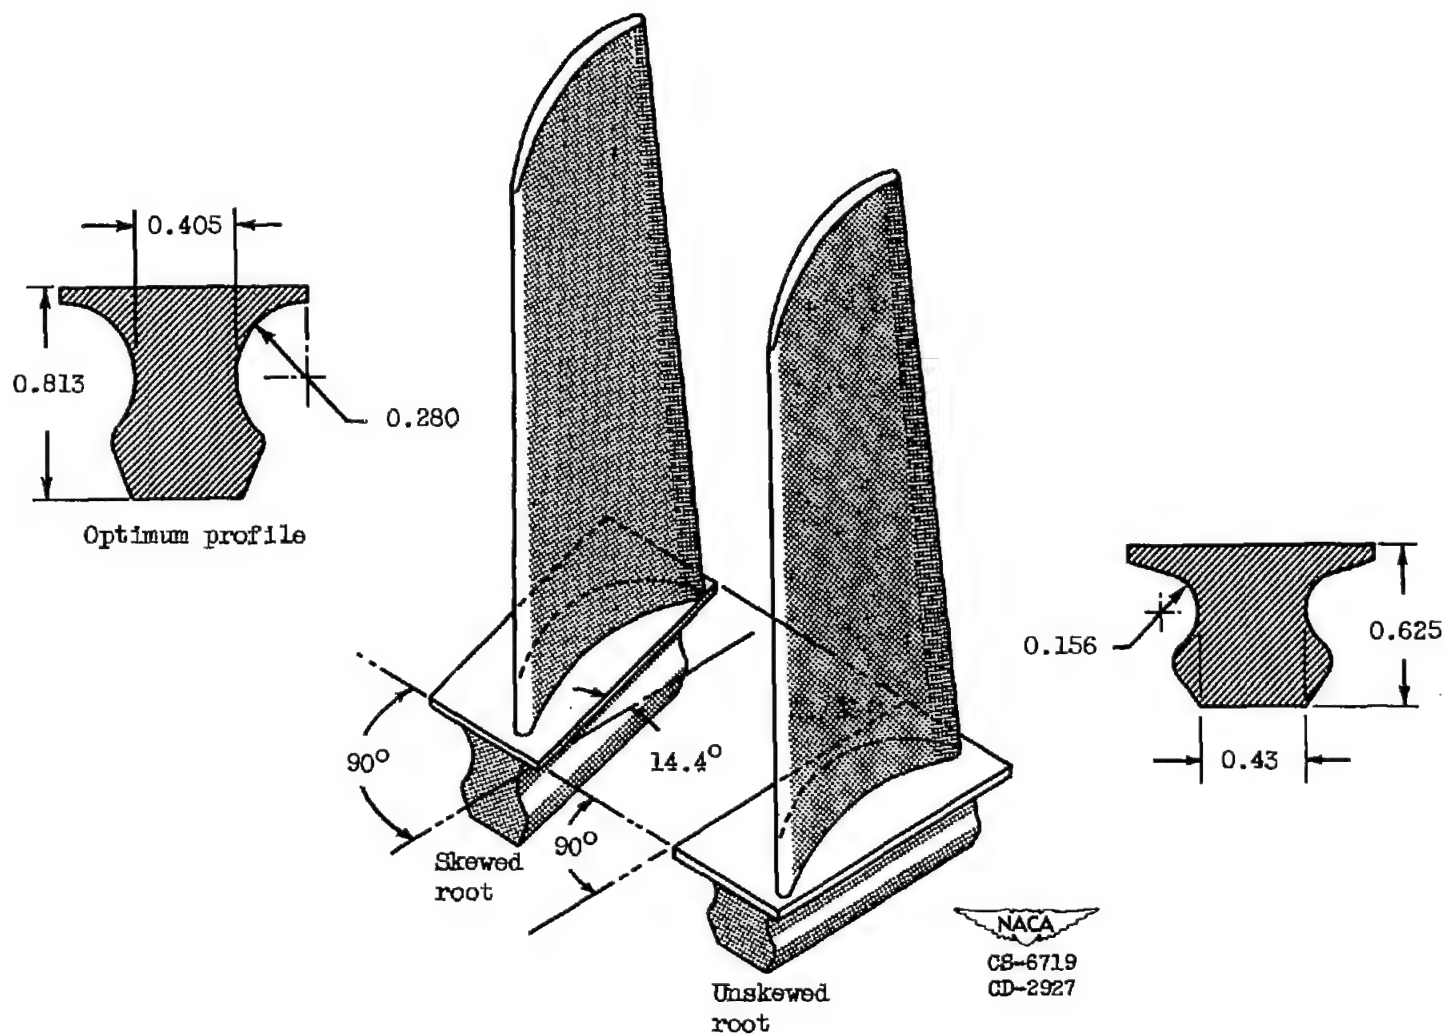
The results of a separate investigation on root profile design are reported in reference 2. In this reference optimum root proportions were determined to give maximum strength in pure tension. The experimental failure load for the small-radius dovetail profile is 37,190 pounds. When the optimum proportions of reference 2 are used, the same load is 41,220 pounds, or an improvement of 11 percent, as established by tensile tests of cermet specimens at 1200° F, reference 4. The increase was caused by a decreased stress concentration factor resulting from increasing the notch radius in the root from 0.156 inch to 0.280 inch. The neck distance in the root had to be reduced from 0.438 inch to 0.405 inch to accommodate the larger-radius root; nevertheless, it is stronger as a result of the lower stress concentration factor. The new root including both the skewing and the new profile is sketched along with the earlier dovetail for comparison in figure 12.

Figure 12. - Dimensions of standard and skewed dovetail cermet blades. (All dimensions are in inches.)

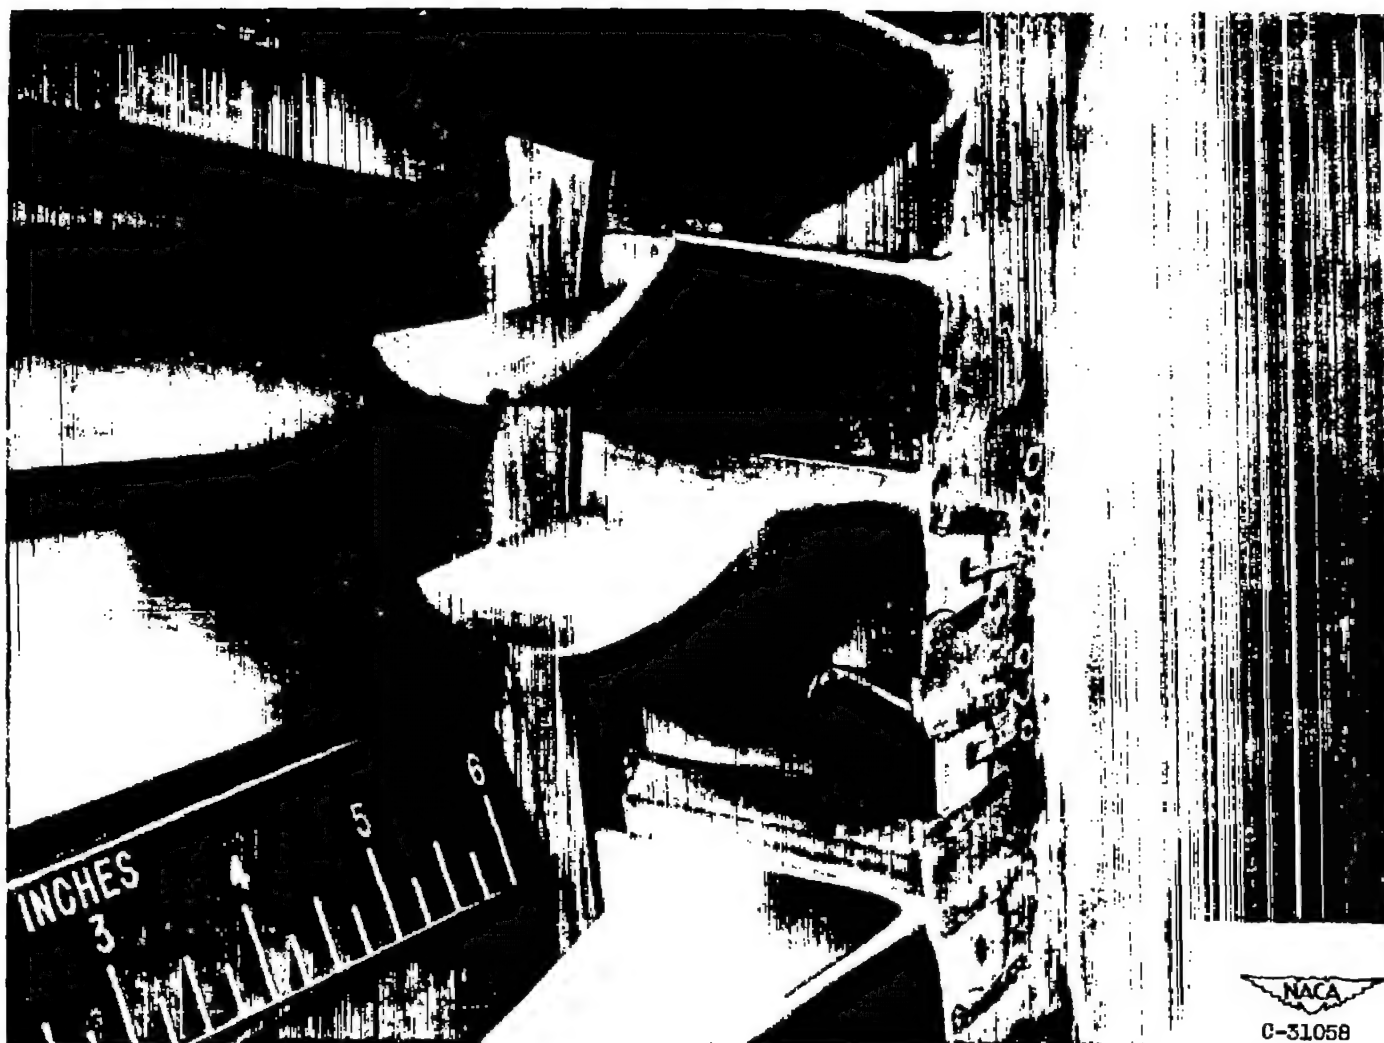
Run 16. - Runs 14 and 15 indicated that an improvement had been accomplished in the redesigned blades but several changes had been incorporated at one time. The root was displaced slightly with respect to the airfoil and was skewed, the notch radius was increased, and attempts had been made to improve the material. To evaluate which changes were primarily responsible for the increased life, six blades of the unskewed interlock design were fabricated from the same material and by the same processes as the cermet blades of runs 14 and 15. These interlock blades were tested in the engine with slightly opened tail cone in the same manner as all earlier tests and the first part of run 14. As noted in the table, these blades lasted only 58 minutes at rated speed, indicating that any material changes were not the major cause for increased life. As shown in figure 16, the failure occurred for the first time between two cermet blades and not adjacent to a metal blade.

Figure 16. - Failure of interlock root made from refined material; run 16.
